The role of transcurrent fault structures in damage typology during the Izmit and Duzce earthquakes (Turkey, 1999)

E. Lekkas

University of Athens, Dept. of Geology, GREECE

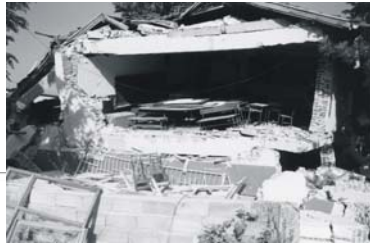
- Some light structures with clay brick bearing walls did not collapse but were severely deformed. One characteristic case was that of a school building (Fig. 5), founded within the downthrown fault block.

Figure 5: A collapsed school building, made of supporting brick masonry, within the subsided block.

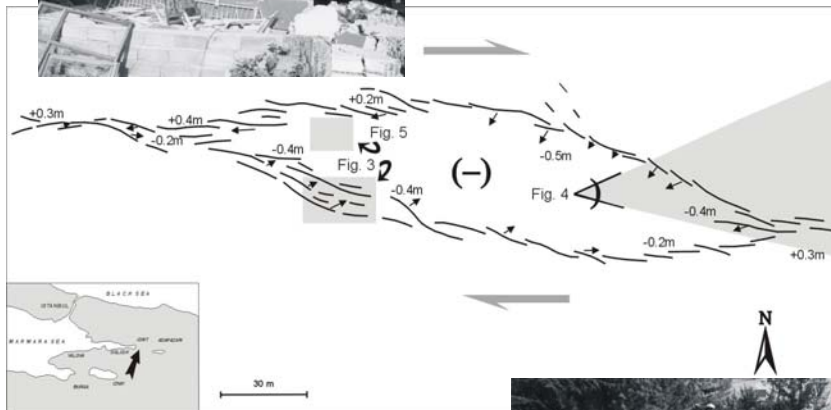
At the eastern outskirts of Gölcük, just south of the highway exit that leads to Izmit, we observed a characteristic case of a 200 by 50 m. block that subsided, because of the formation of a pull-apart basin along the fault trace (Fig. 2).

The main fault splayed into two 200-m. long segments, which merged again after running a distance of 200 m. These two faults bounded a 200 by 50 m area (long axis oriented E-W) that was downthrown for about 80 cm maximum and corresponded to a small-scale pull-apart basin (Aydin & Nur [12]). The kinematics of the two bounding faults ranged between dip-slip and oblique-slip and this could be confirmed by the offset of linear-type features, as roads, pavements, water pipes, etc. (Fig. 3).

Figure 2: Map of the seismic fault trace east of Gölcük. A small-scale pull-apart basin has been formed. The kinematics of each segment is also marked. The arrows and numbers show the direction and amount of offset, respectively.

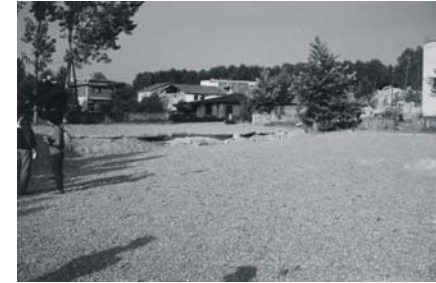
- Along the fault trace, all structures were destroyed totally or suffered severe damage. The foundations could not absorb the imposed differential deformation at the foundation level. The type of collapse was the same as described in the previous cases (Fig. 4).
- Within the pull apart, the damage was again considerable. The collapse of R/C buildings was a common sight and the ones that remained standing had suffered heavy structural damage, mostly because of (i) settlement of the foundation formations, (ii) soil compaction close to the foundations, and (iii) block rotation

Figure 4: Partial view of the northern fault segment, with principal vertical offset component (normal faulting). The arrow shows a collapsed construction that lay on the prolongation of the fault.

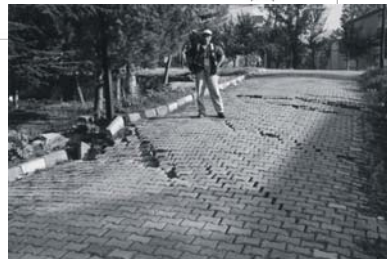
Figure 3: Partial view of the southern fault segment, with vertical (normal) and horizontal (right-lateral) offset components, marked by the dislocation of flagstones. At least five breaks are visible.

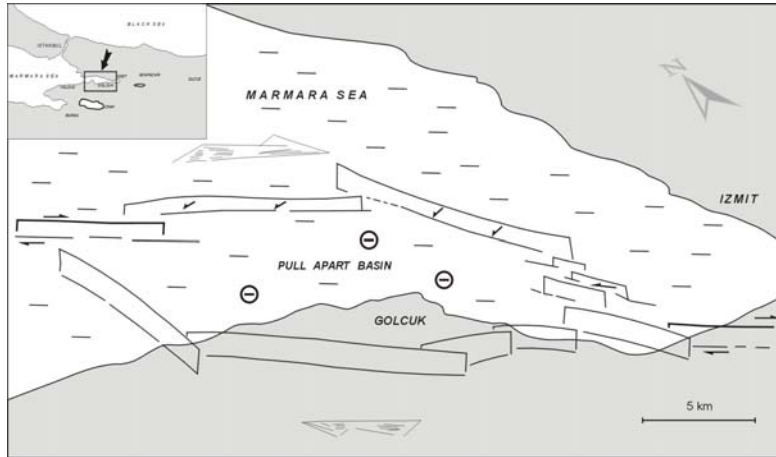
This subsidence was not caused by ground settlement or landsliding; the typical forms that accompany such site effects were absent (crown, head, and bulging toe, characteristic of landslides, or ground spreading and associated soil cracks that are connected with settlement). On the contrary, areas were subjected to block depression, or even slight block-rotation. The amount of subsidence was up to a few meters and whole areas – fault blocks were downthrown (Fig. 6).

Figure 6: Interpretation of the subsidence on the Gölçük – Deringmendere coastal zone, which corresponds to a pull-apart basin, formed along the transcurrent fault zone.

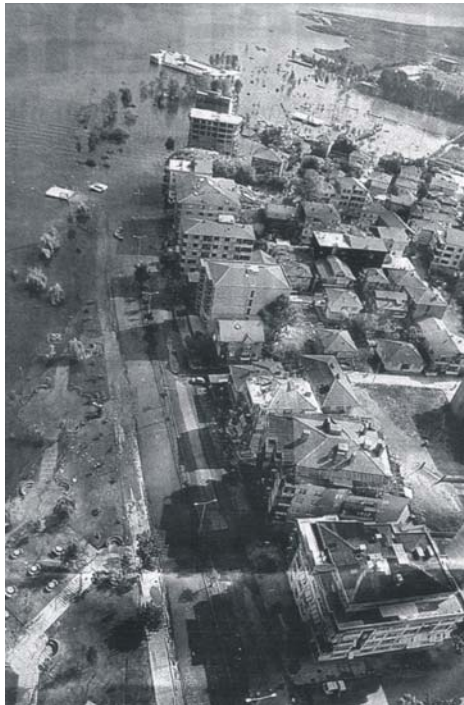
- Inhabited areas subsided by as much as 4 m, which rendered them uninhabitable and virtually useless for any purpose (Fig. 7).
- A large proportion of the existing constructions collapsed, and most of buildings suffered heavy damage. This is attributed not only to the initial seismic shaking, but also to the amplification of it, a common effect within basin-type subsiding blocks.

Figure 7: Subsidence at the coastal zone of Gölçük. The location is within a pull-apart basin created by the distribution of strike-slip movement.

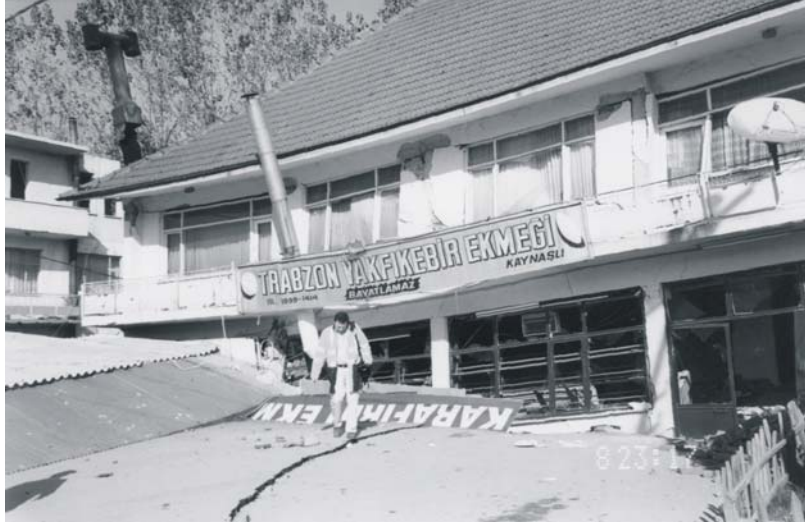
- Sinking of constructions, as much as 5 m, accompanied by partial collapse or not. This was caused by intense fracturing of the foundation formations, usually accompanied by lateral spreading, settlement, etc. (Fig. 8).

Figure 8: A construction with R/C frame, sunk into the loose surficial formations within a flower structure.

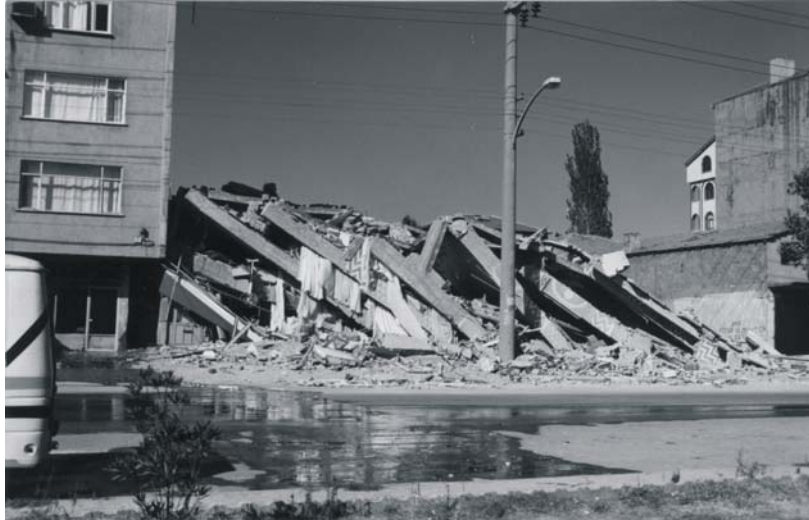
The vast majority of collapses - toppling were directed towards the east or west, that is, parallel to the fault strike and sense of offset, regardless of construction type, height, morphology, plan, etc. (Fig. 9). Systematic eastward or westward collapse was also observed at buildings whose plan did not favor it -- high E-W/N-S aspect ratio.

Because the majority of buildings did not have ground- and first-story shear walls, the collapse was facilitated (Lekkas et al. [1]). The absence of beams, existence of slab-beams, insufficient ties hooks, and the poor quality of concrete as well as primary and secondary reinforcing steel contributed to collapse. In these cases the vast majority of construction collapsed or toppled to the east or west.

Figure 9: Collapsed multi-story buildings, lying close to the seismic fault. Eastward and westward card-deck collapse is indicative of large surficial displacement, a fact confirmed by instrumental recordings.
