**EARTHQUAKE ENGINEERING  
RESEARCH INSTITUTE**

# The Grevena (Central-North) Greece Earthquake Series of May 13, 1995

*Pan. G. Carydis, Professor of Earthquake Engineering, NTUA; Konst. S. Holeva, Civil Engineer, Emergency Response Department, EPPO; Eft. C. Lekkas, Geologist, Assistant Professor, Athens University; and Tax. D. Papadopoulos, Geophysicist, Assistant Professor, Athens University, are members of the scientific emergency committee advising the interministerial coordinating board of Greece. The authors visited the earthquake-stricken area a few hours after the main shock and stayed on site for two days. The mission was initiated and supported by the Earthquake Planning and Protection Organization (EPPO).*

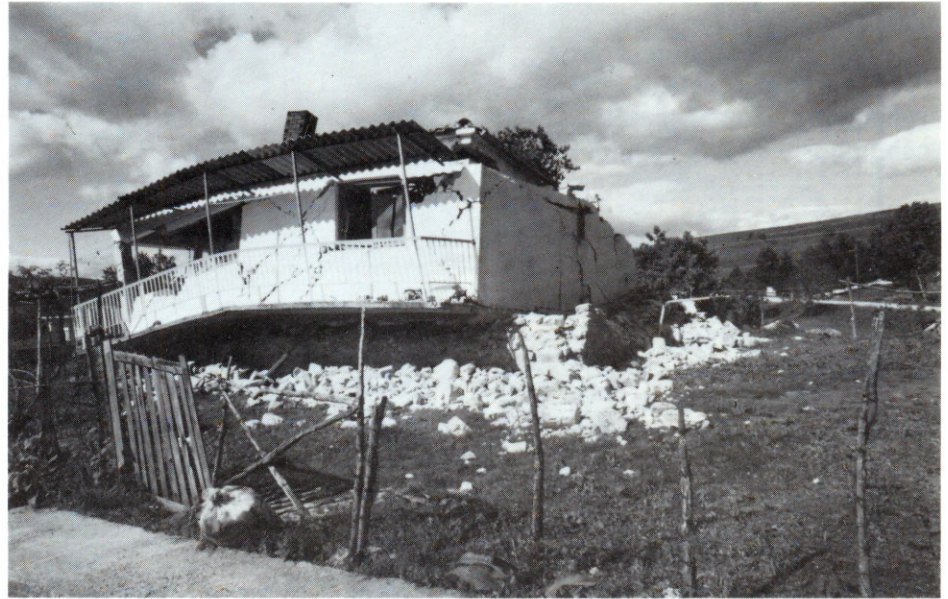
**Figure 1**—Typical damage to the buildings in the region struck by the earthquake.

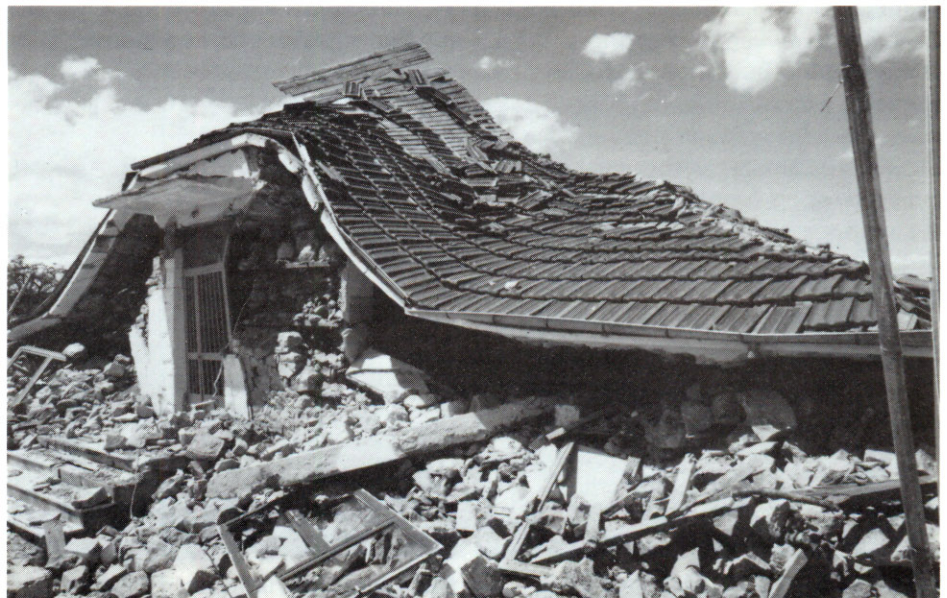
**Figure 2**—The remains of the school in the village of Kendron.

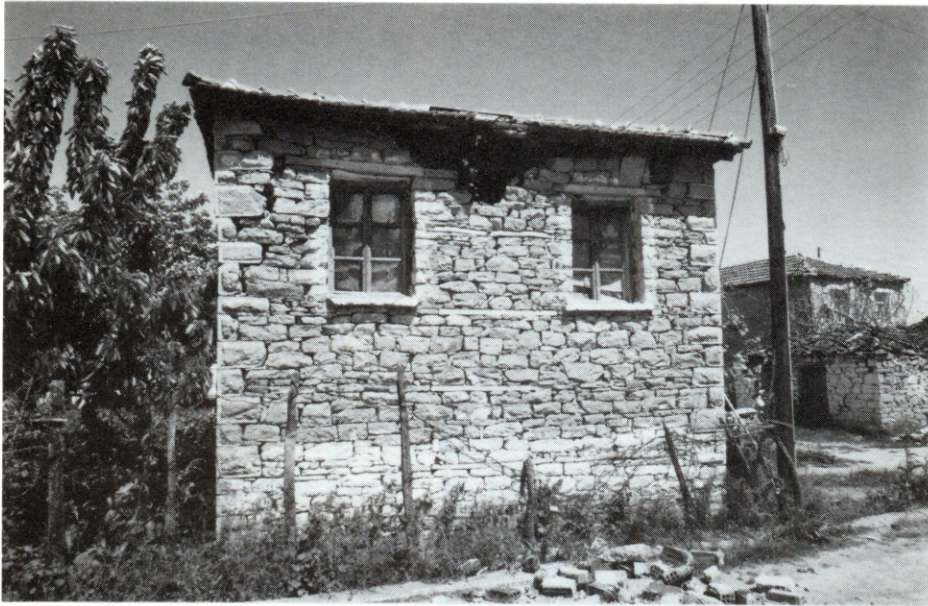
**Figure 4**—Typical old house of the region reinforced with wooden beams. Houses of the same type but without the wooden beams suffered much more damage or collapsed.

Some of the non-engineered buildings in the region are adobe or rubble masonry with wooden reinforcing beams. This older type of building sustained the earthquake without suffering extensive damage. Most of the collapses were observed in one- or two-story rubble masonry houses built mainly without mortar. A considerable portion of these houses had been renovated using concrete and heavy tile roofs which were incompatible with the older building.

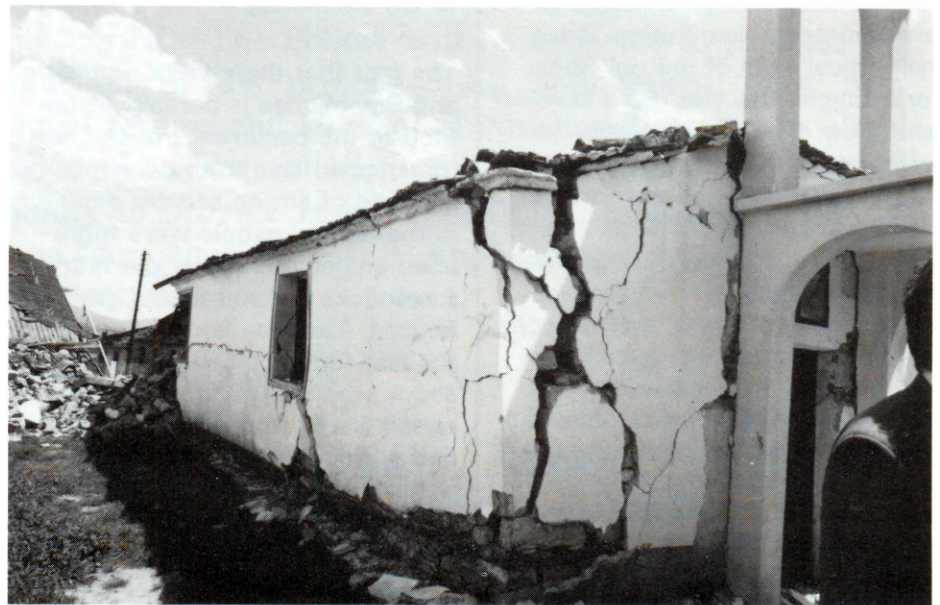
**Figure 5**—The damaged church in the village of Knidi. The cracks are typical of the strong vertical component of the ground motion.

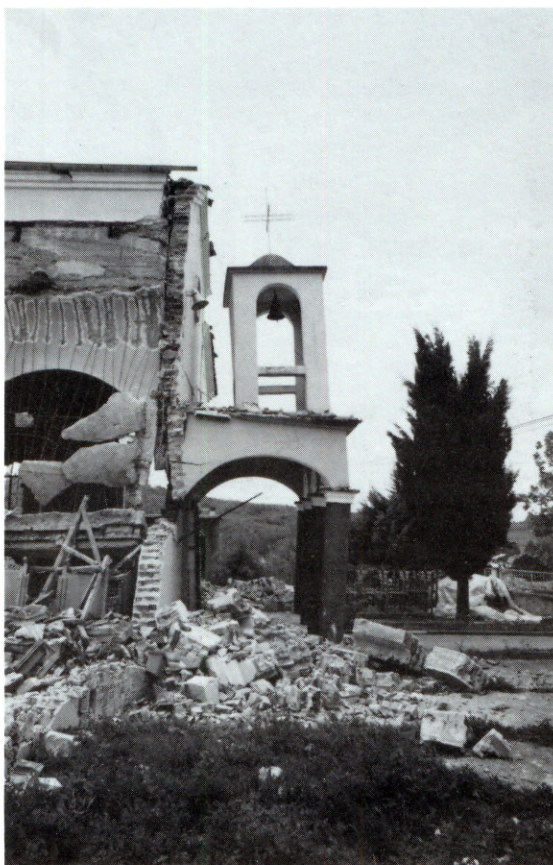
*Figure 6—A view of a damaged church in the village of Kendron.*
