# Advances in Earthquake Engineering

## The Kobe Earthquake: Geodynamical Aspects

## **The seismotectonic setting of the Kobe area (Japan) - the concomitant geodynamic phenomena of the Hanshin Earthquake (17 January 1995)**

E. Lekkas, H. Kranis, M. Leounakis, P. Stylianos

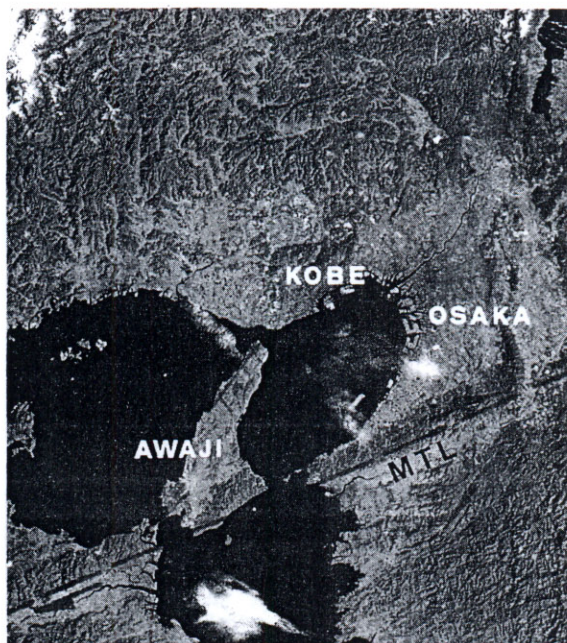
Figure 2: Satellite image of Kinki and adjacent areas including Awaji Island, where the reactivated Nojima Fault lies. (MTL: Median Tectonic Line)

The greater area of Kinki i.e. Osaka, Kobe and Kyoto, as well as the offshore regions, together with Awaji Island (Awajishima), is characterised by the presence of such a structure, namely a first-order fault zone (Median Tectonic Line), of pure dextral strike-slip (The Research Group for Active Faults in Japan <sup>2,3</sup>). This EW trending zone runs south of Awaji Island and the Gulf of Osaka (Fig. 2).

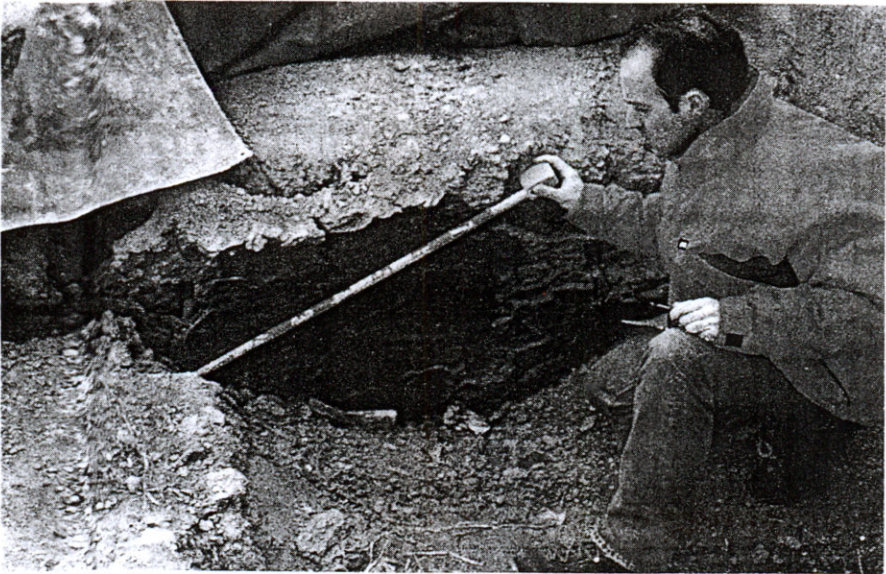
Figure 4: A portion of the surface of the reactivated Nojima Fault showing the relative movement between the fractured blocks.

As already mentioned, the earthquake of 17 January 1995 is due to dextral faulting. In fact, the faulting mechanism displays significant strike-slip, which prevails over the vertical component. The focal mechanism solution comes in agreement with the reactivated Nojima Fault on Awaji Island. The latter displayed a maximum horizontal slip of 1.7 m and a vertical slip of 1.3 m; its reverse character, too, is clear. The reactivated portion of the fault is particularly apparent for about 9 km, running parallel to the western coast of the island. However, inside the city of Kobe, and due to intense urbanisation, no indisputable outcrops of an activated fault were observed. Nevertheless, certain cracks, judging from the geometrical and tectonic analysis that was carried out, could be seismic fractures.

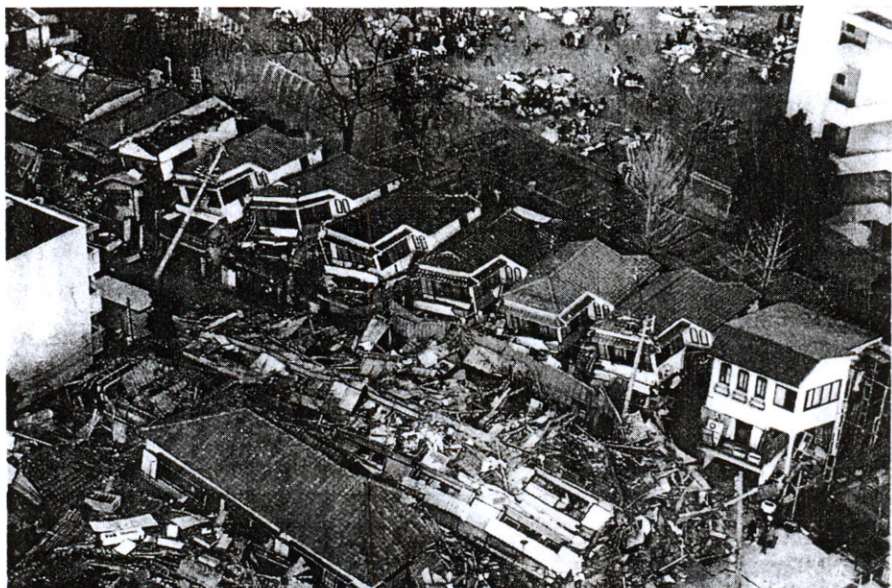
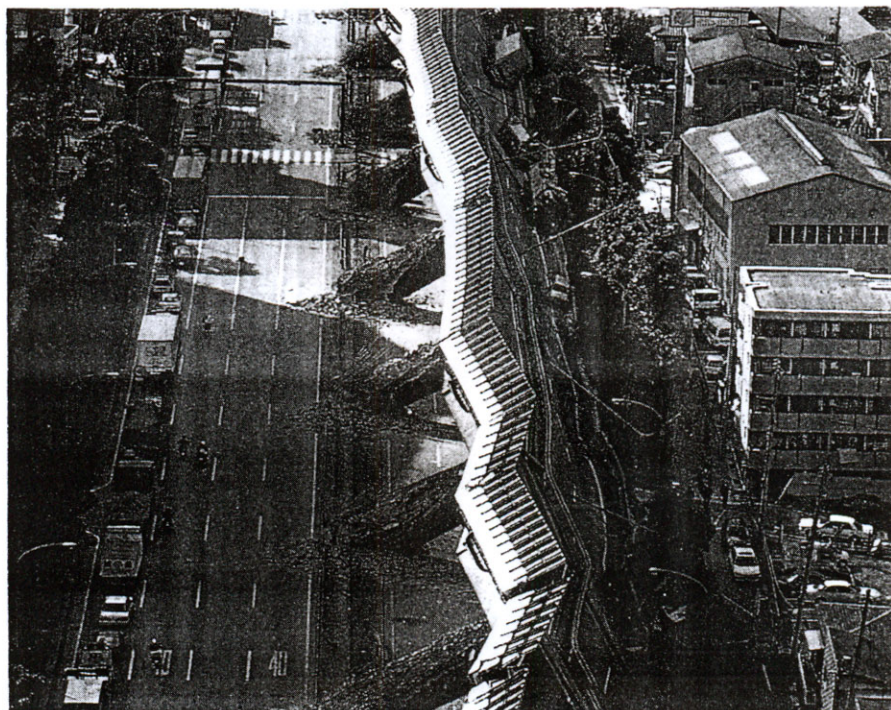
Figure 11: Damage in wooden houses and the highway during the Hanshin Earthquake.

After the initial recording and mapping of the damage, the first conclusion that can be drawn is the linear distribution of them along a NE-SW trending zone 25 km in length by approximately 1 km in breadth; along this zone the intensities were of grade 7 (the maximum in the Japanese intensity scale) (Figs 9, 10). On the other hand, the recorded intensities outside this narrow zone were significantly lower, with some exceptions of isolated islets of high values, as a result of the manifestation of concomitant geodynamic phenomena (Fig. 11).

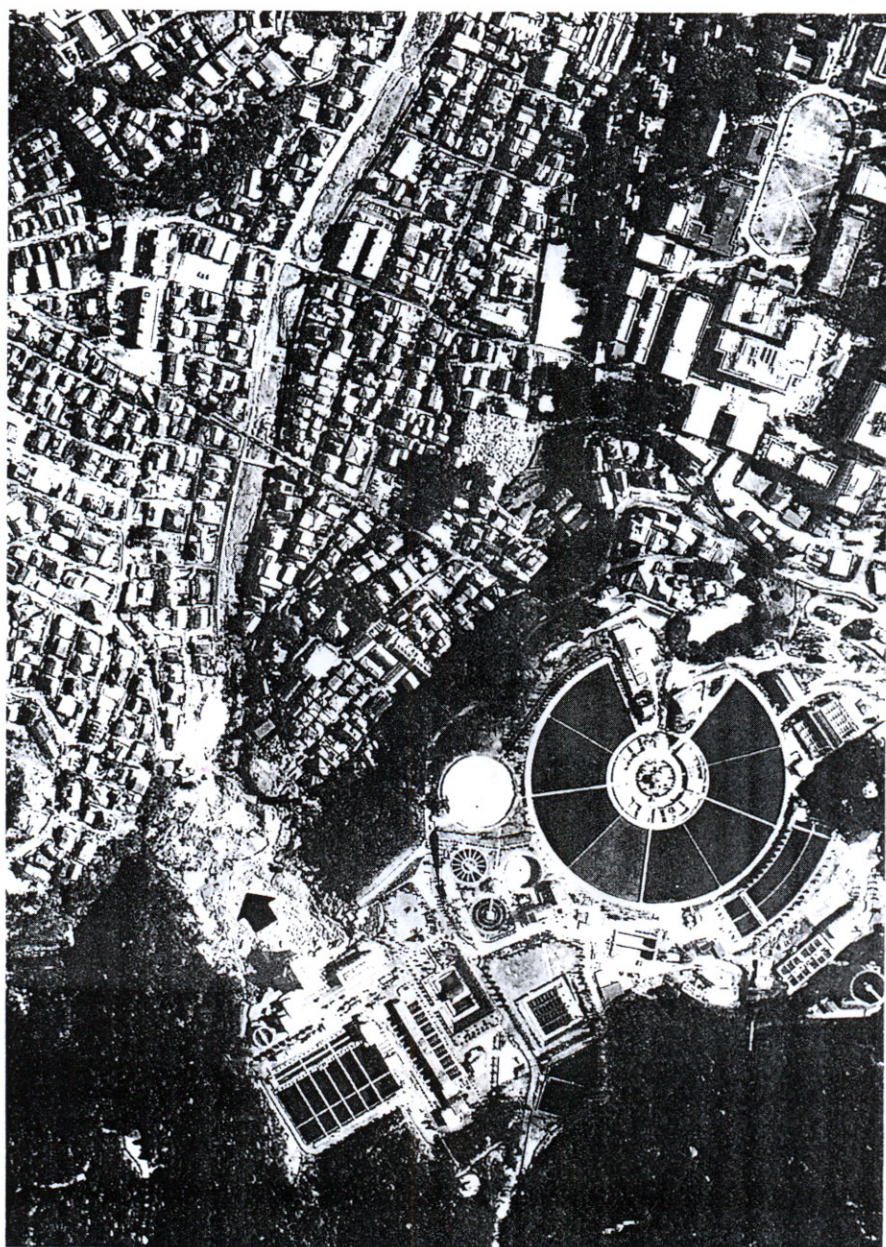
On the other hand, the landslides that occurred inside the urban area resulted in the loss of human lives, as well as material damage. (Fig. 12) These landslides were bigger in dimension, up to 100 m. This differentiation is attributed, according to the data collected so far, not only to the proximity of the slide locations with the activated fault zone, but also to the extent of human interventions with the natural environment, that is to say buildings, roads and the formation of artificial slopes.

Figure 12: A landslide (marked with arrow) that occurred in the urban area.
