Reduction of landslide risk by the use of mild explosives: the case of Rhodes city (Greece)

Abstract

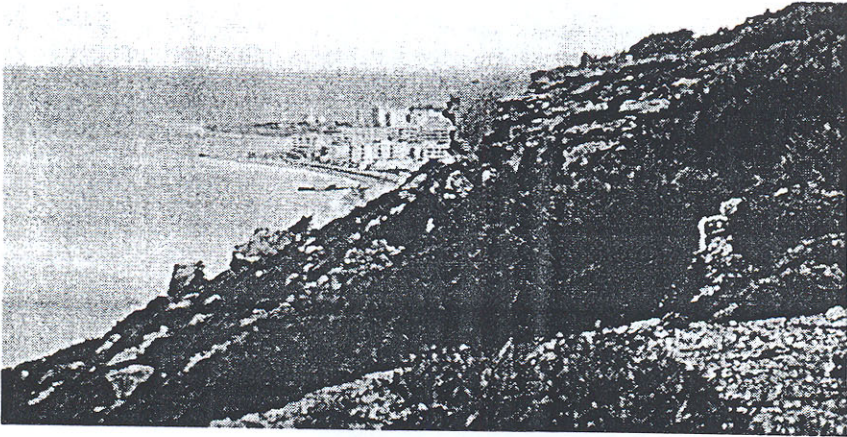
Figure 6: Demolition of the unstable rock boulders at the Monte Smith hill.

As it is illustrated on the table I, the method proposing the controlled shattering – demolition of the rock boulders is the most advantageous, so its implementation took place. What seemed important was the selection of blocks that were to be exploded before the drilling and emplacement of the explosives. Priority was given to the selection of risky boulders so that fewer slides would occur after the vibrations of the explosion-demolition (Fig. 6).

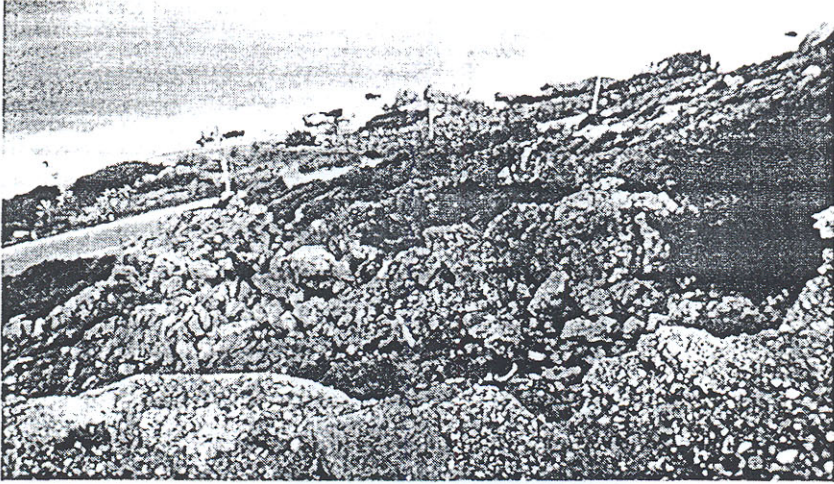
Figure 7: Coarse fragments as a result of the demolition-shattering of rocky boulders at the slope of Monte Smith hill. The coarse material contributes to the reduction of slope erosion, which is responsible for the manifestation of such phenomena.

Measures were taken for the protection of the citizens from the demolition such as interruption of the car circulation. No shattered fragments fell onto the road pavement. On the contrary, they covered a part of the slope (downslope of the boulders) a fact that decreased the erosion of the lower formation which has already been mentioned to have been the main reason for the lack of support of the rocky mass (Fig. 7).

After the drilling and emplacement of the explosives, the shattering of the hanging' boulders was accomplished successfully and the smaller fragments covered the area downslope. This fact contributed to the reduction and control of the erosion of the underlying formation, which was responsible for the gradual loss of support of the rocky mass.
