# **Extreme storms in regions of steep morphology: The case of the 2016 Messenia flood event**

**Emmanuel Skourtsos, Michael Diakakis, Christos Filis,  
Haralambos Kranis, Spyridon Mavroulis and Efthymios Lekkas**

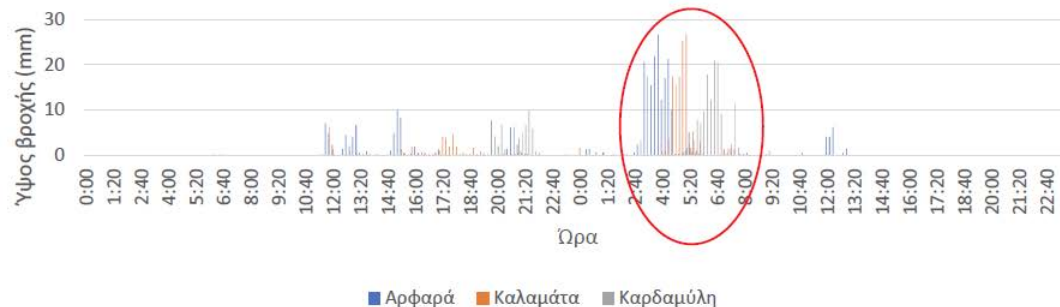
Participation height (mm)

Rainfall height reached up to 162.2mm in one and a half hour at Arfara station of the National Athens Observatory, 15 km north of Kalamata City, while Kalamata and Kardamili stations received 102 mm and 107.8 mm in 50 minutes respectively.
